LNL-8000 Port Configuration

LNL-8000 Port 1 is not communicating with OnGuard.

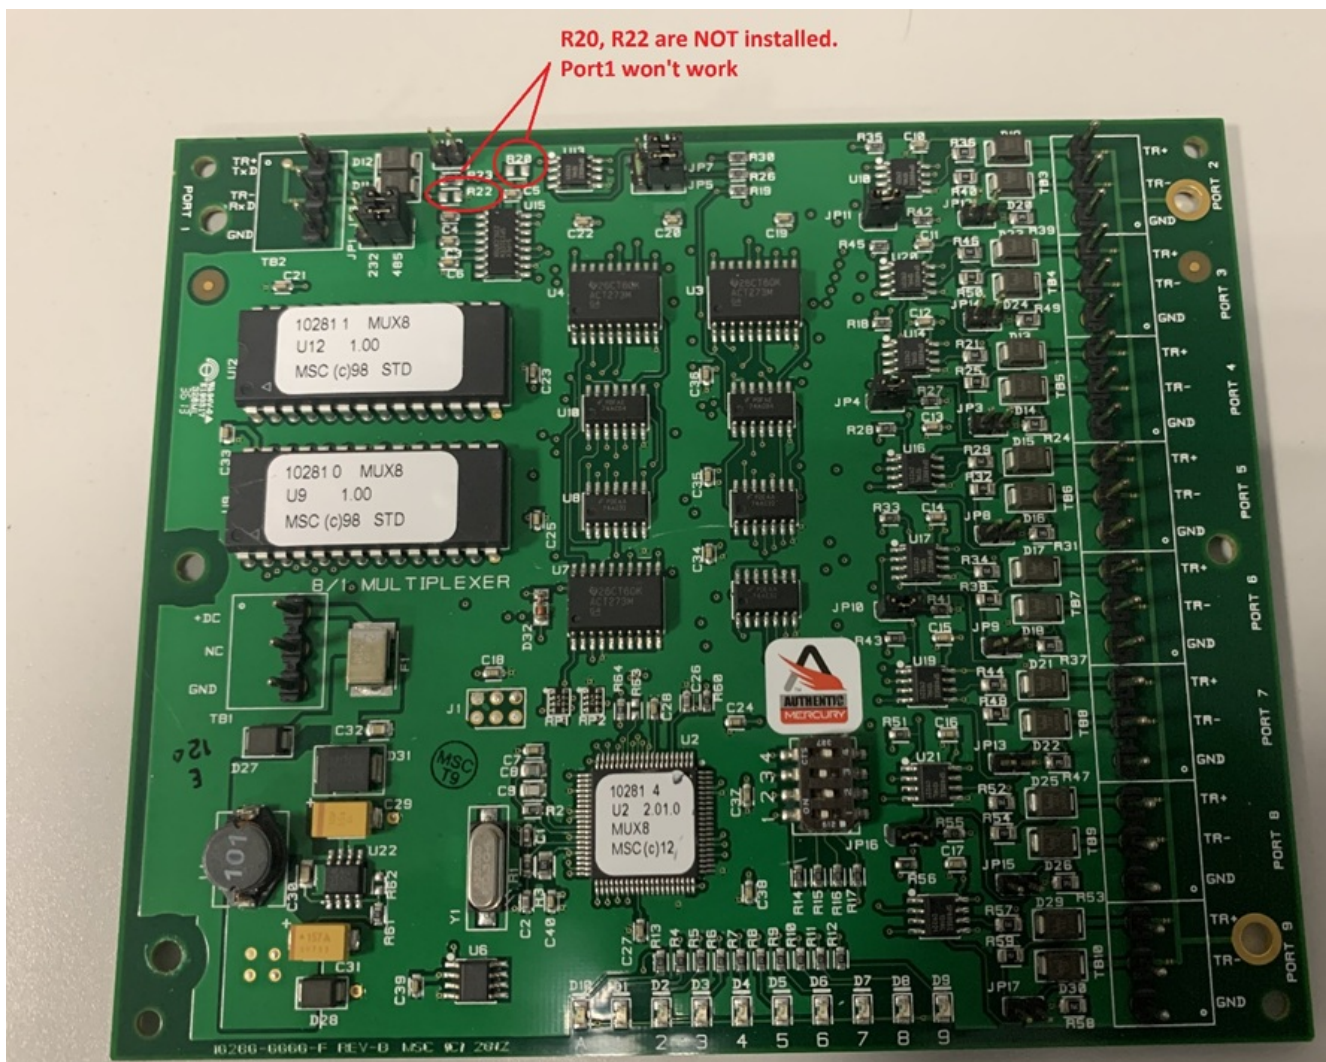
- Rev C¹: Resistors R20 and R22 are NOT installed. Therefore, Port 1 will not function. Use new Rev C boards.

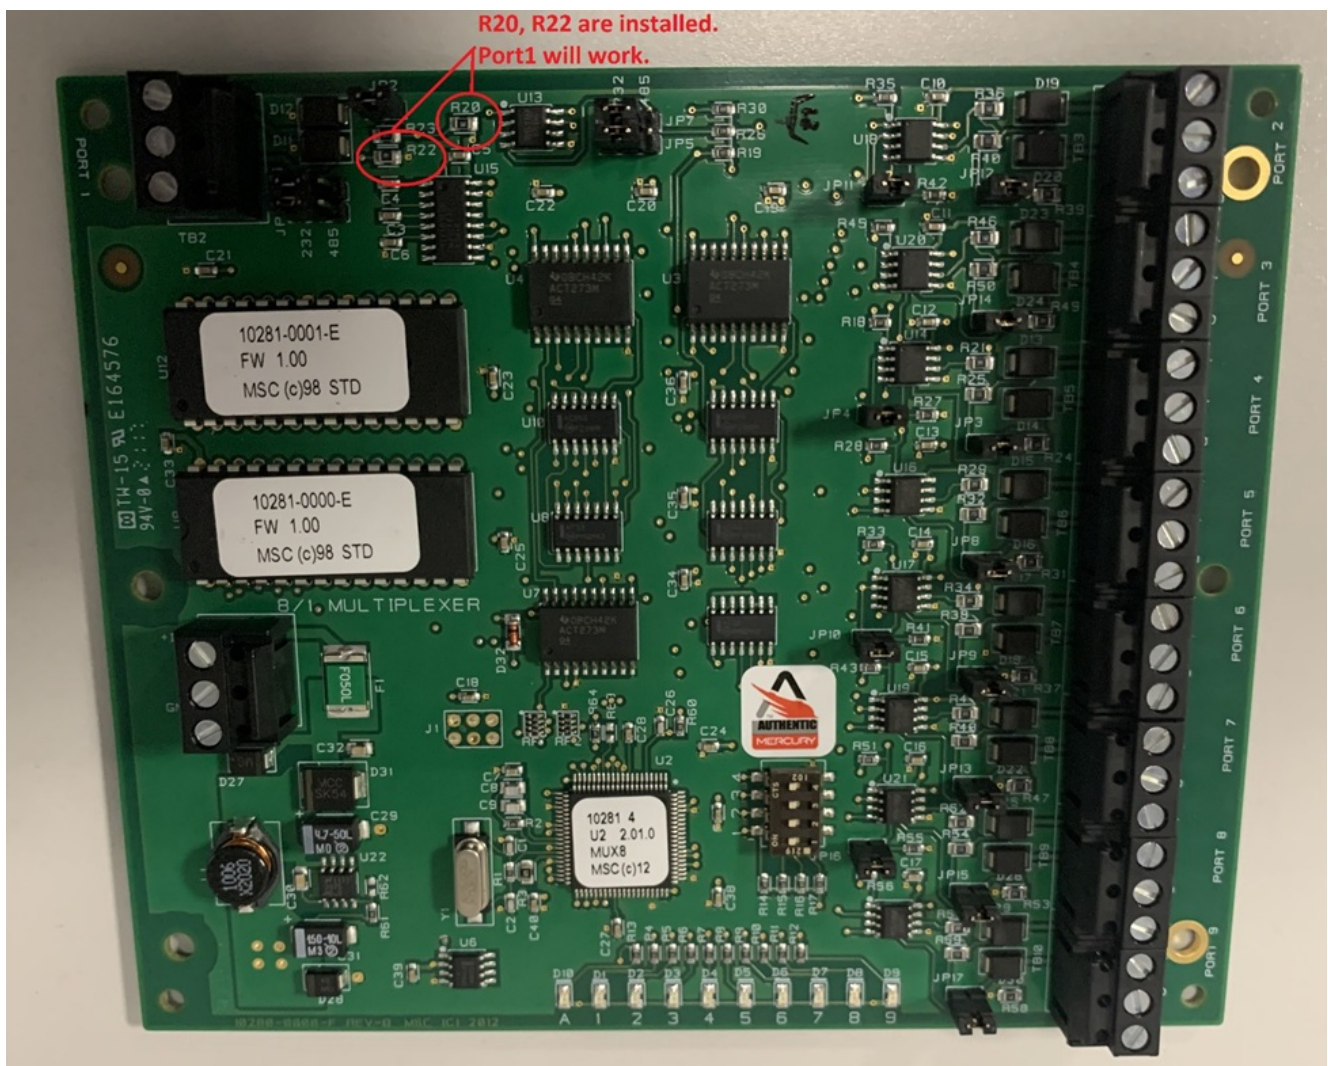
- Rev C²: Resistors R20 and R22 are installed. This board works with all the controllers (see **Note** below).
