LNL-8000 Port Configuration

Symptom

LNL-8000 Port 1 is not communicating with OnGuard.

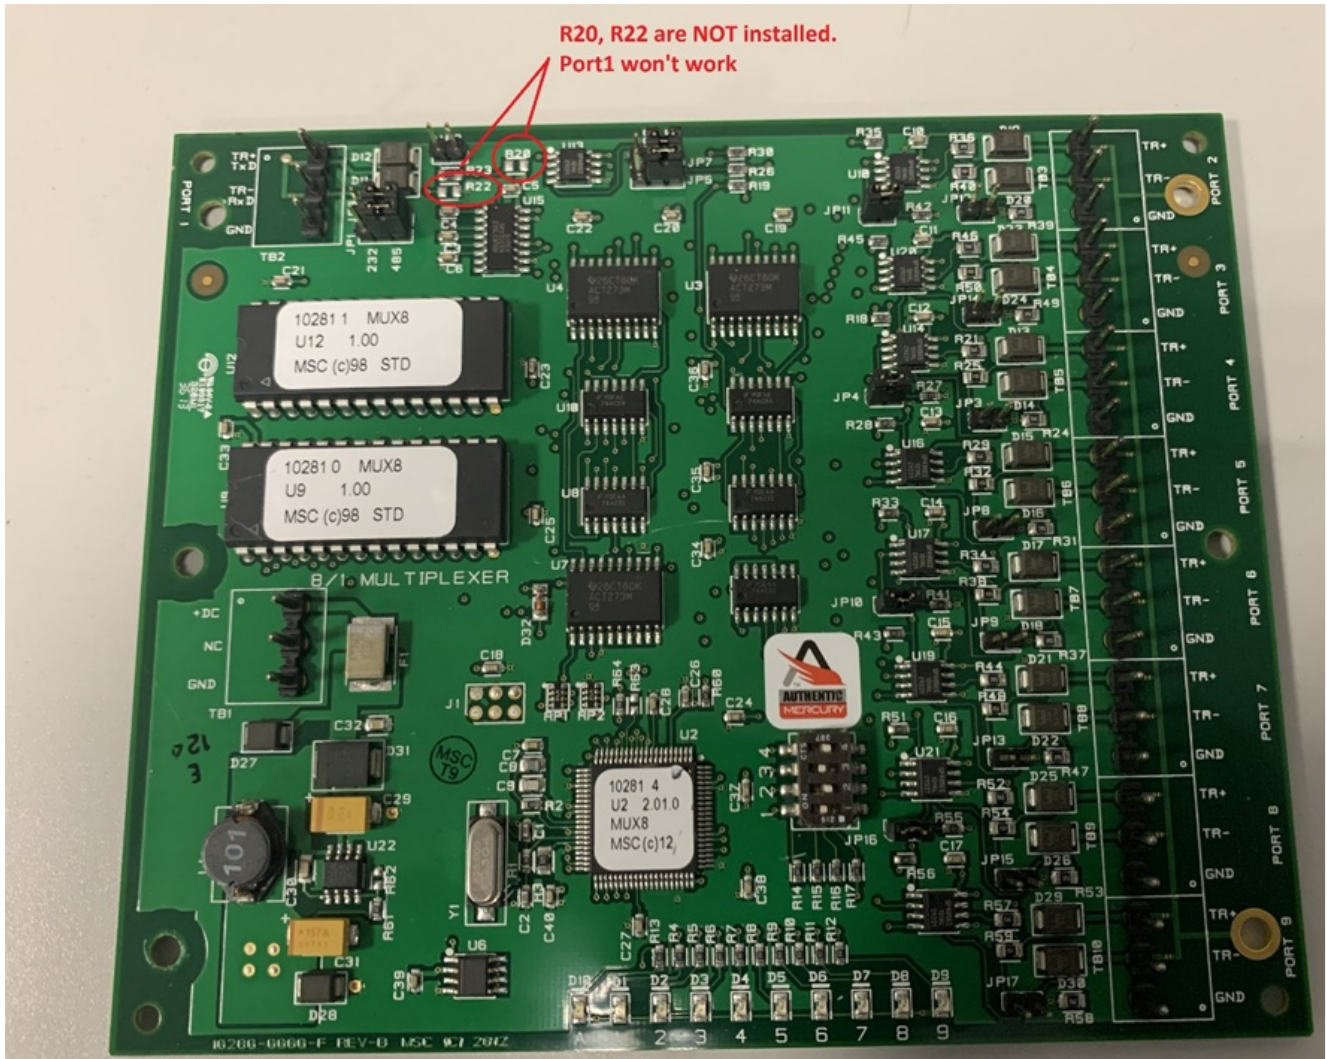
- Rev C¹: Resistors R20 and R22 are NOT installed. Therefore, Port 1 will not function. Use new Rev C boards.

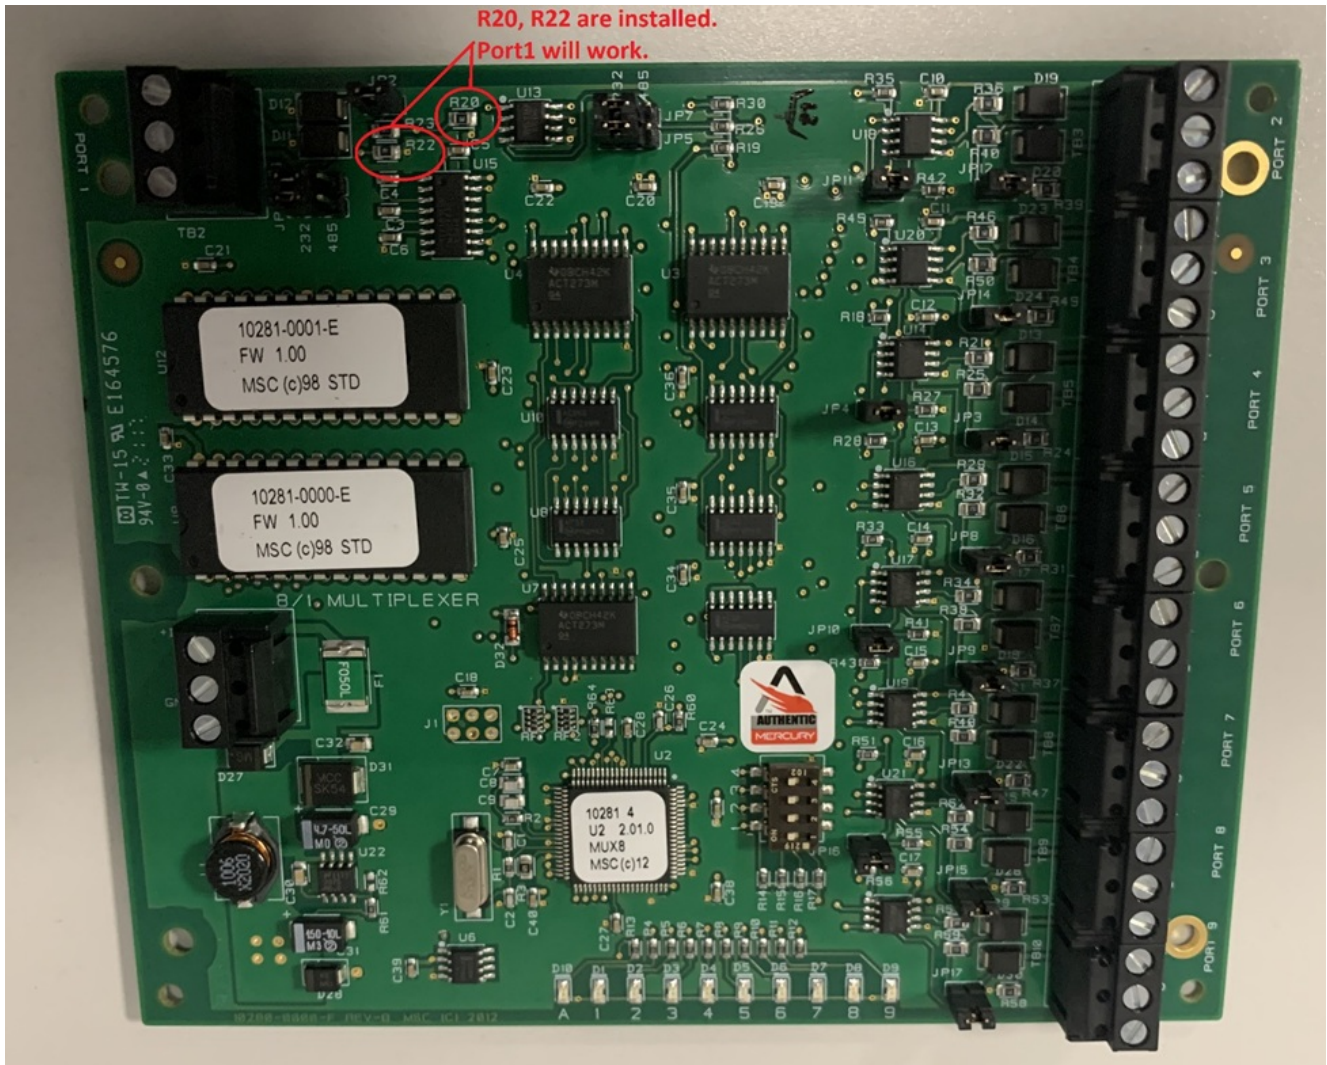
- Rev C²: Resistors R20 and R22 are installed. This board works with all the controllers (see **Note** below).

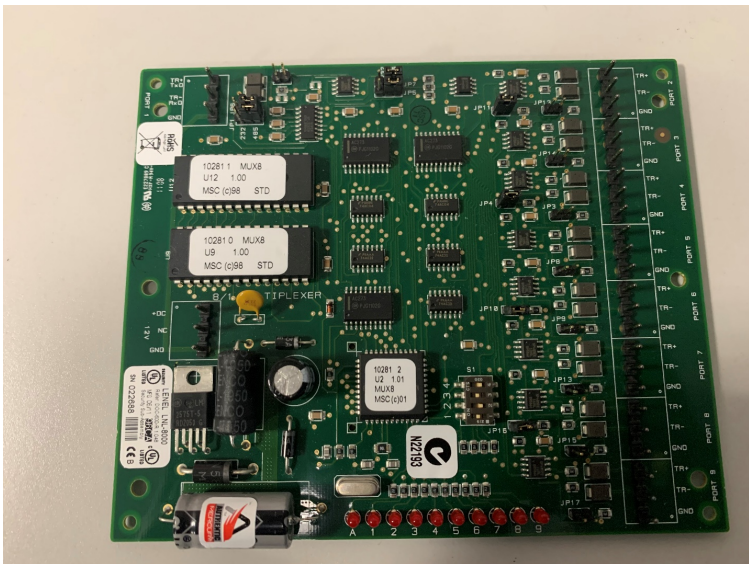
- Old LNL-8000 boards with U2 rev 1.01. LNL-X3300
